Alkincoates Park - Walled Garden

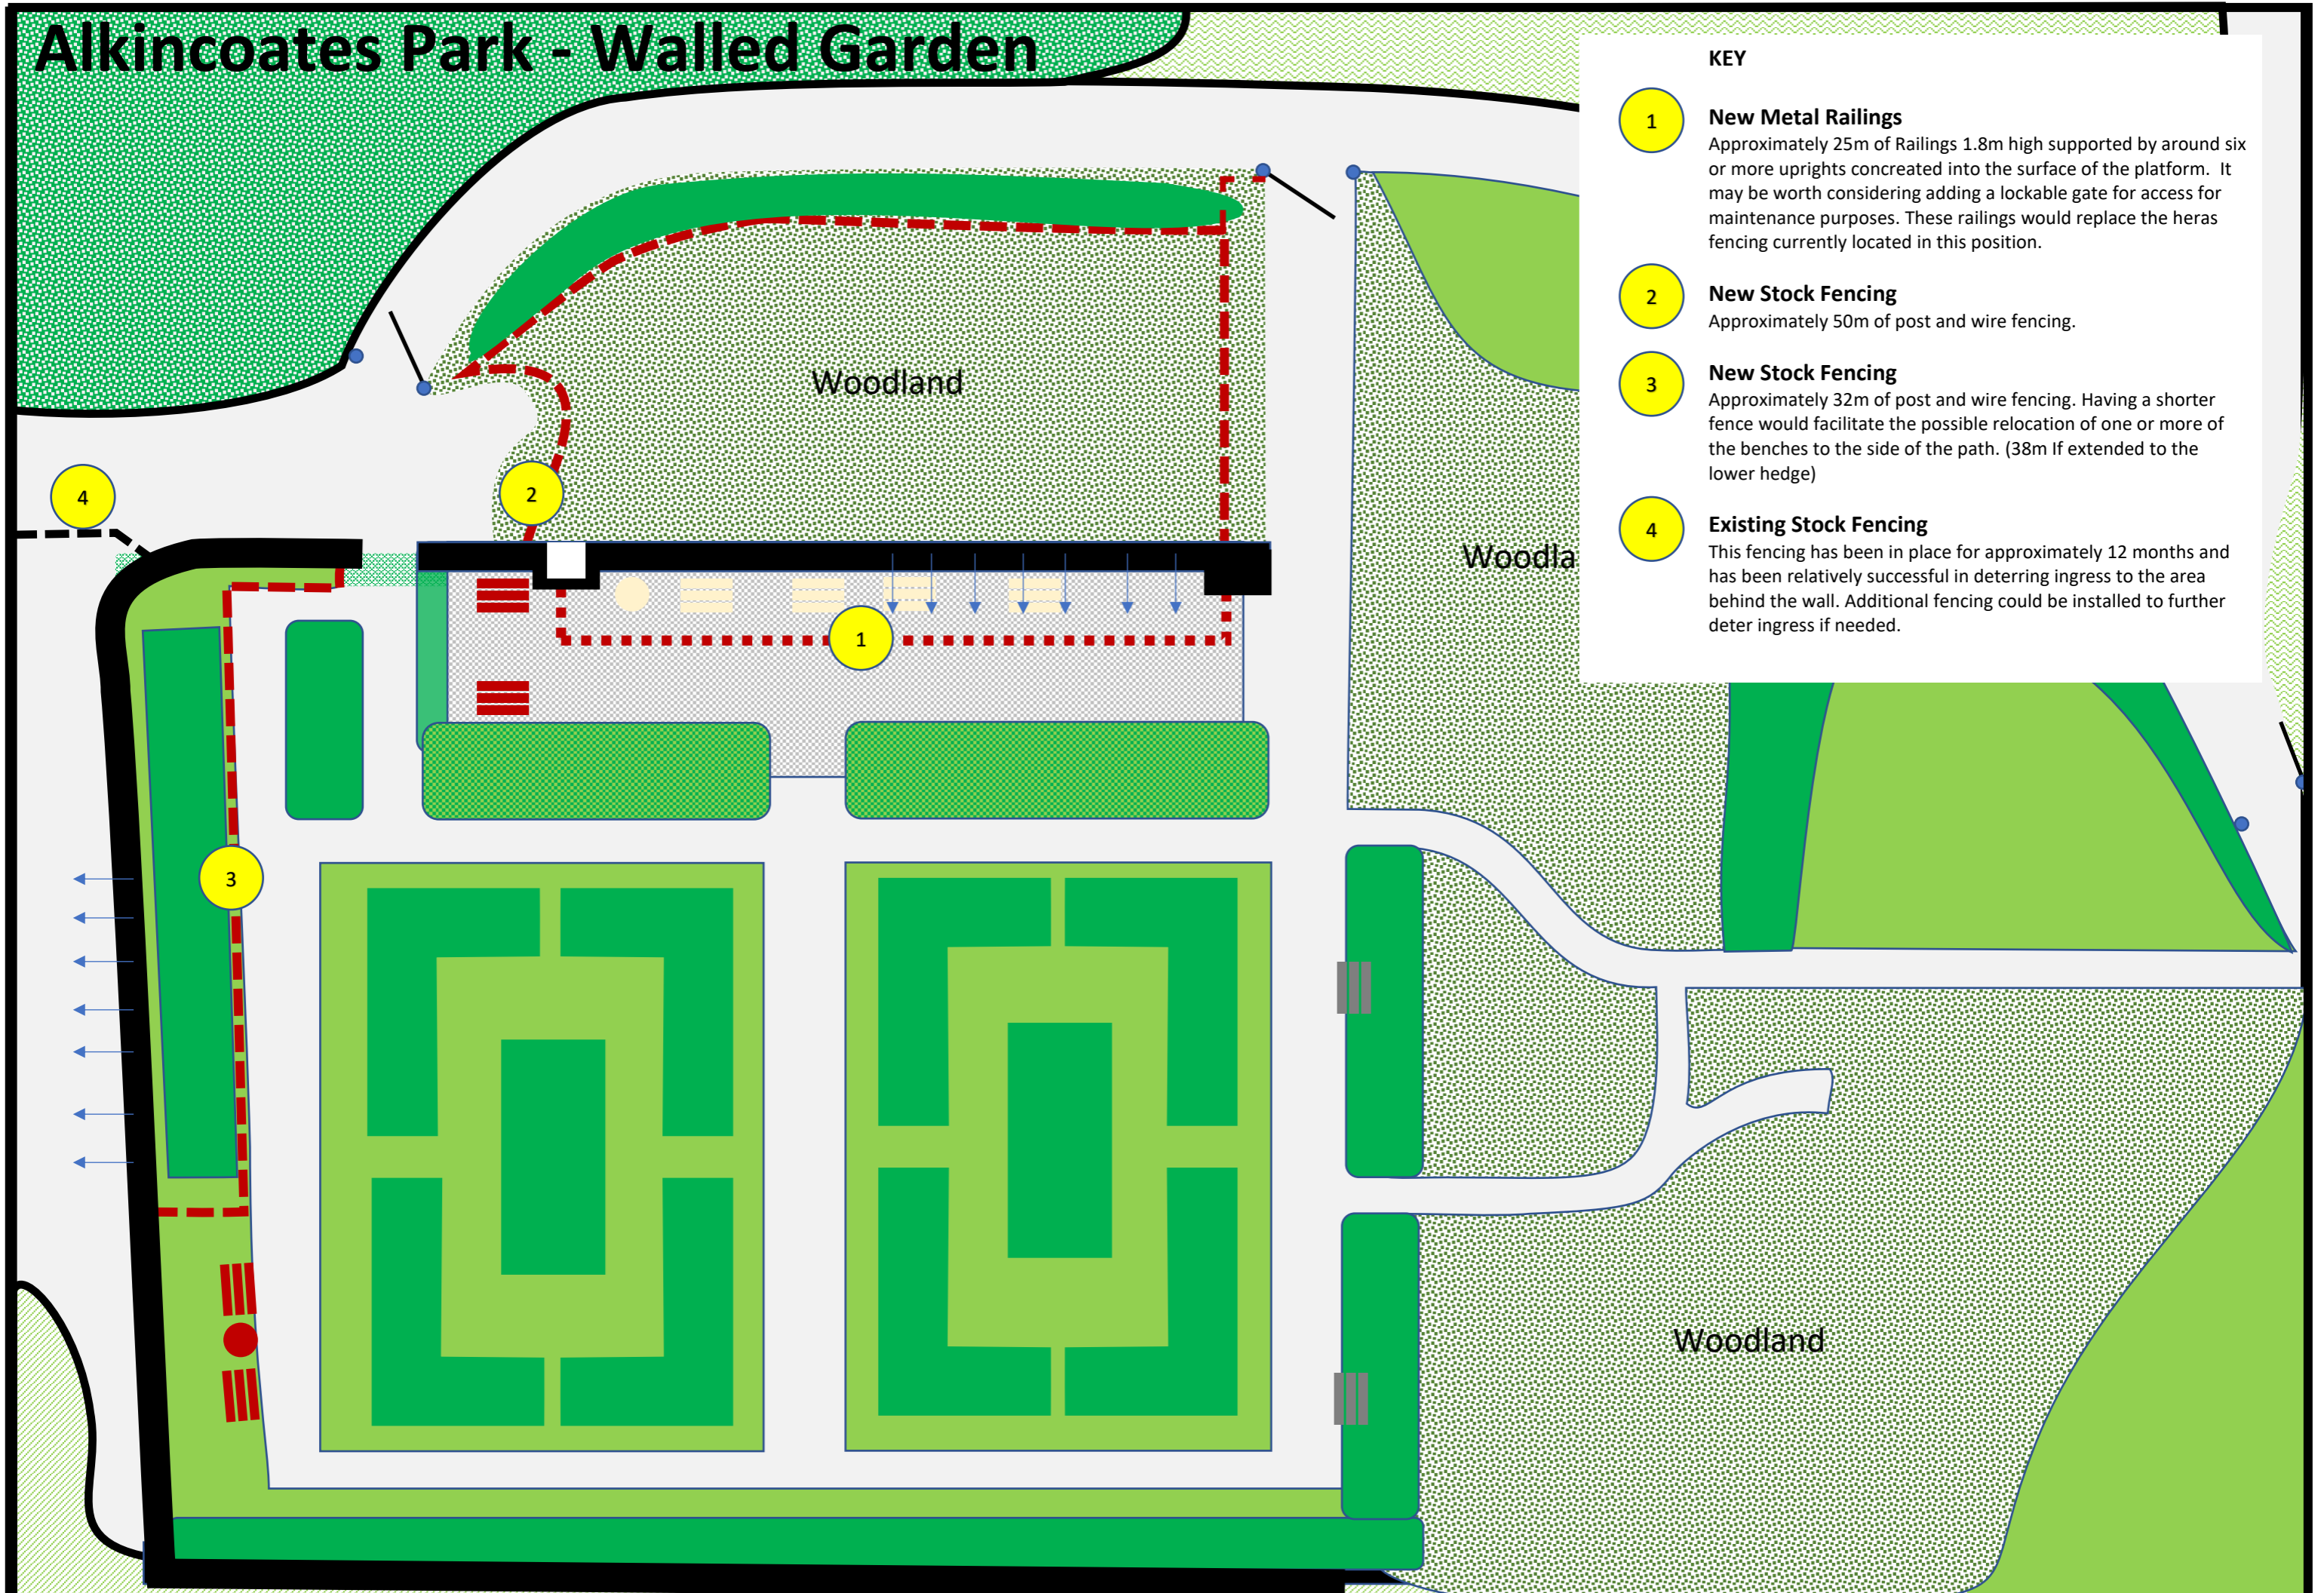
- 1 New Metal Railings**
 Approximately 25m of Railings 1.8m high supported by around six or more uprights concreted into the surface of the platform. It may be worth considering adding a lockable gate for access for maintenance purposes. These railings would replace the heras fencing currently located in this position.
- 2 New Stock Fencing**
 Approximately 50m of post and wire fencing.
- 3 New Stock Fencing**
 Approximately 32m of post and wire fencing. Having a shorter fence would facilitate the possible relocation of one or more of the benches to the side of the path. (38m if extended to the lower hedge)
- 4 Existing Stock Fencing**
 This fencing has been in place for approximately 12 months and has been relatively successful in deterring ingress to the area behind the wall. Additional fencing could be installed to further deter ingress if needed.
